NSWCCD-63-TR-2001/104 March 2001

Survivability, Structures, and Materials Directorate Technical Report

Identification of Welldeck Washout Discharge Constituents: Summary Report

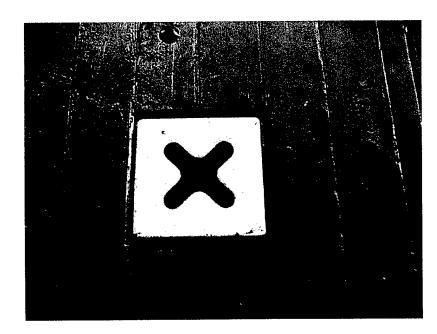
Hose Connection Adapter Installed in Access Cover

As with the LCAC, the LCU can burn either jet fuel or diesel fuel marine. The craft masters stated that the LPD-4 class ship always provides the LCU with jet fuel. During the assessment, the team had the opportunity to observe the crew testing a fueling adapter manufactured by ships force. The adapter allows fueling to be conducted using the same Carter aircraft underwing fueling nozzle currently used on LCACs and aircraft. Since the adapter was successfully used to fuel both tanks, the crew welded all adapter connection points to eliminate potential leakage points and will continue to fuel the LCU using the new adapter. This adapter will serve as an excellent MPCD for all LCUs.
